NISSAN DIESEL AMERICA, INC. RECALL BULLETIN

DATE: JULY 31, 2000
 MODEL YEAR: 1999 AND 2000
 MODELS AFFECTED: UD1200/UD1400
 BULLETIN #: SC - 156
 FILE AT THE END OF THE STEERING SECTION OF THE TECHNICAL BULLETIN BINDER

VOLUNTARY SAFETY RECALL CAMPAIGN #00V - 156:
1999 AND 2000 MODEL YEAR UD1200 AND UD1400 MODEL VEHICLES STEERING GEAR BOX FASTENER
TORQUE INSPECTION AND REPLACEMENT

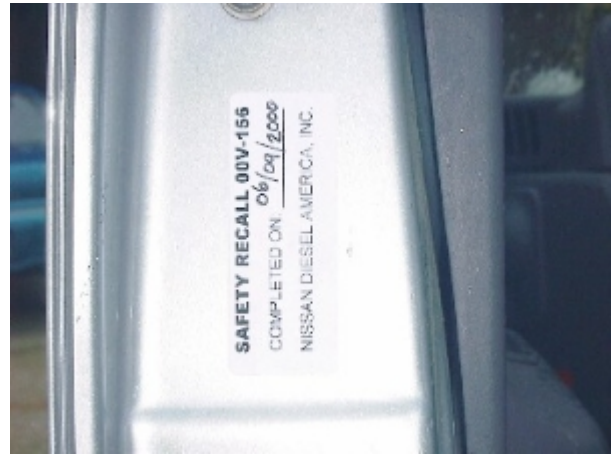
THE LABEL INDICATES THAT THE VEHICLE HAS BEEN PREVIOUSLY REPAIRED.

a. If the involved vehicle has the label on the inside of the driver's door as shown above, the recall has already been performed and no further action is required.

b. If the involved vehicle *does not have* the label on the inside of the driver's door, verify through the Vehicle Service Notification screen of the NDANET2 system that the recall is required. Complete the safety recall, if the vehicle requires it, according to the following instructions.

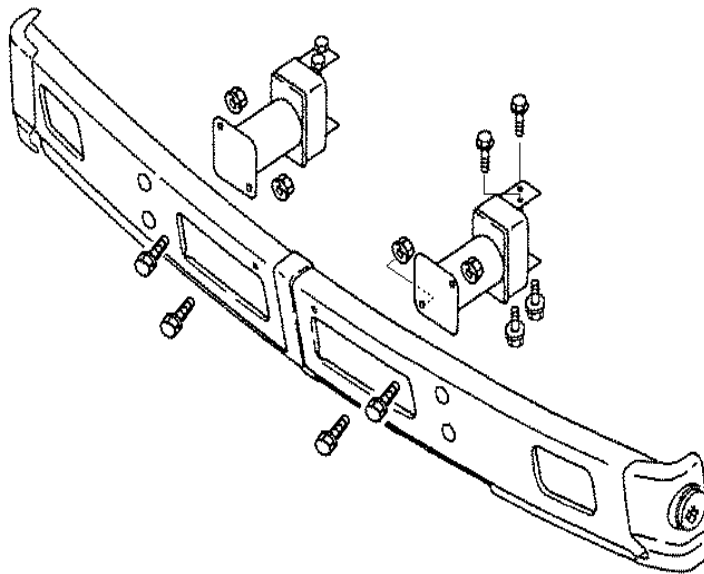
REMOVE BUMPER MOUNTING BOLTS AND NUTS (4 EACH)

2. Using 14 mm sockets and wrenches, remove the four bumper mounting bolts and nuts, as shown below, and remove the bumper. Save all pieces for reinstallation.

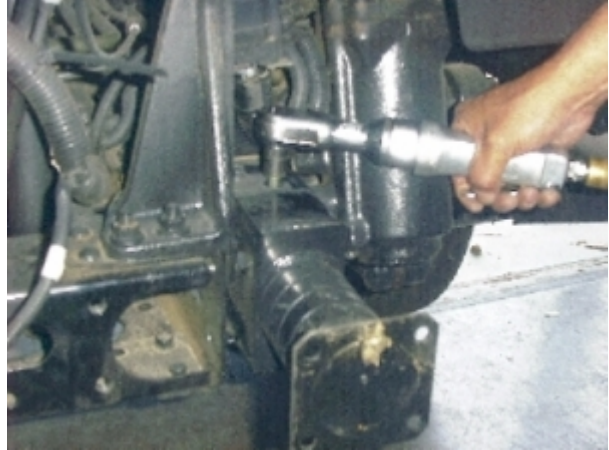
**DRIVER'S SIDE BUMPER
MOUNTING BRACKET
(SHOWN WITH BUMPER REMOVED)**

REMOVE DRIVER'S SIDE BUMPER MOUNTING BRACKET (4 BOLTS)

3. Using a 14 mm socket, remove the four mounting bolts (two on the top and two on the bottom) from the driver's side bumper mounting bracket as shown below. Remove the bumper mounting bracket from the frame. Save all pieces for reinstallation.

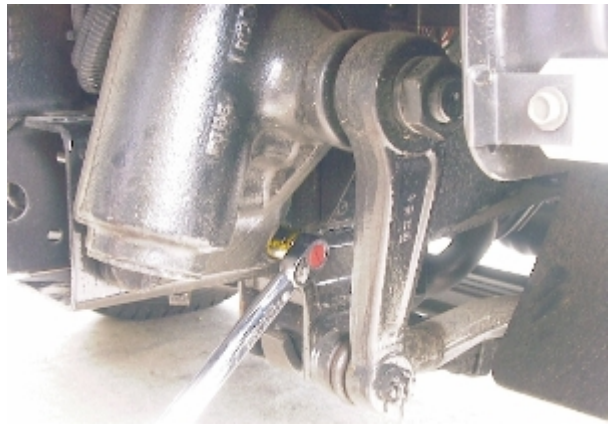
**REMOVE THE TWO REAR MOUNTING BOLTS
AND INSPECT BOLT THREADS FOR DAMAGE**

4. Using a 19 mm socket, remove the two rear mounting bolts, as shown below, and inspect the bolt threads for damage such as crossed or stripped threads.

a. If ***no thread damage*** is present on either bolt, discard both bolts and replace them with new bolts using part number 08044-2401A. Tighten both bolts to 69 ft-lb (93 N-m) torque*. If full torque was obtained on both bolts, proceed directly to [Step 7](#).

***NOTE: If *full torque cannot be obtained* on either bolt, discard both bolts and proceed directly to Step 5.**

b. If thread damage is present on either bolt, discard both bolts and proceed directly to Step 5.

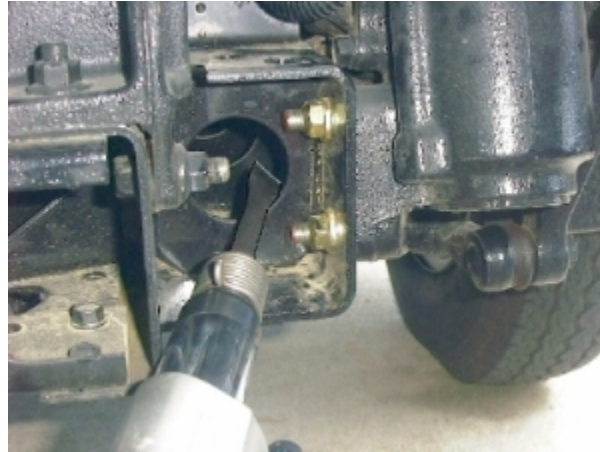
ACCESS TO REAR MOUNTING NUTS WELDED TO INSIDE OF FRAME RAIL THROUGH HOLE IN FRAME

AIR-DRIVEN CHISEL (OR EQUIVALENT) TO REMOVE REAR MOUNTING NUTS

5. Remove the two rear mounting nuts welded to the inside of the frame rail by either of the two following methods:

a. Place the blade of an air-driven chisel, or strike a cold chisel with a heavy hammer, against the welded nut. Ensure that the chisel blade is as flush against the inside of the frame rail as possible to prevent impact damage to the inside of the frame and to ensure a clean and complete separation of the welded nut from the frame.

b. Partially thread the removed bolt into the nut approximately two turns and strike the head of the bolt with a heavy hammer to break the welded nut loose from the frame.

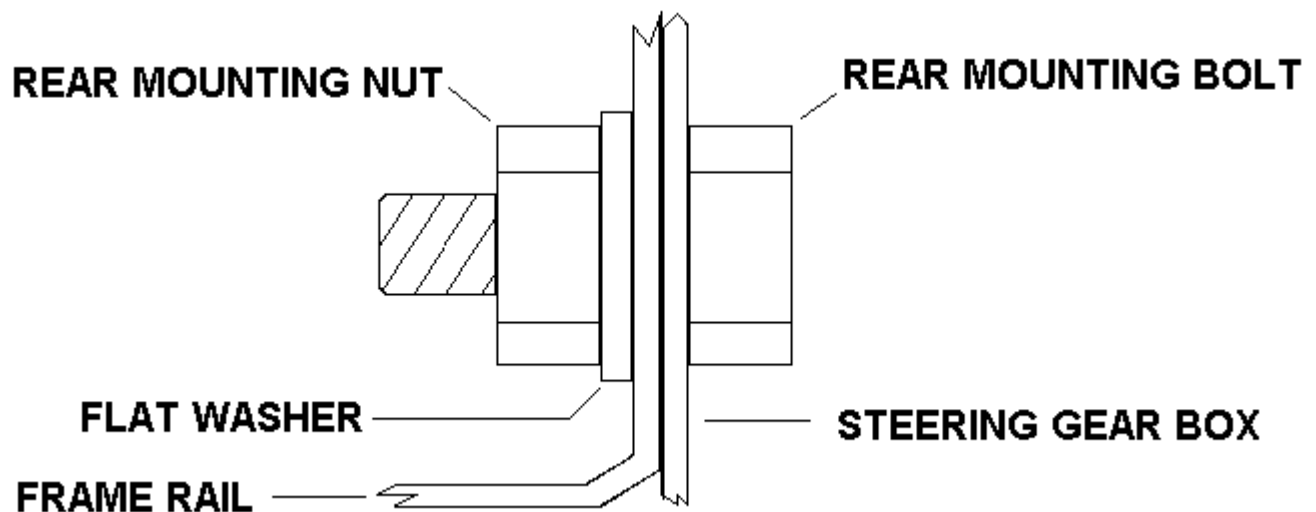
TIGHTEN STEERING GEAR BOX FRONT STUD MOUNTING NUTS

6. Install new bolts, nuts and flat washers in the rear mounting location as shown below. Using a 19 mm socket and torque wrench, tighten the bolts to 69 ft-lb (93 N·m) torque.

7. Using a 19 mm socket and torque wrench, tighten the steering gear box front stud mounting nuts, as shown in the diagram for Step 6 above, to 69 ft-lb (93 N·m) torque.
