DATE: JANUARY 31, 1997

CHASSIS MODEL: UD1400

BULLETIN #: CL - 03

ENGINE FLYWHEEL RUNOUT CORRECTION

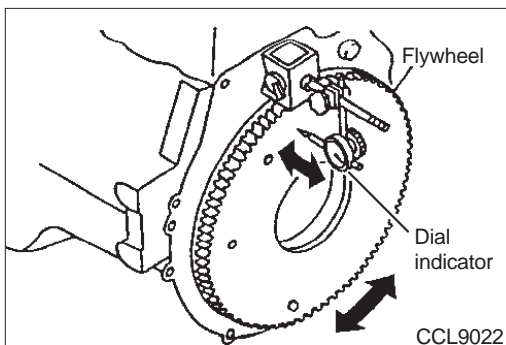
FLYWHEEL INSPECTION

- Page CL-6-3 (Rev. 4/94) incorrectly states that engine flywheel runout (total indicator reading) should be less than 0.0059 in. (0.15 mm).

The correct engine flywheel runout (total indicator reading) should be less than 0.0039 in. (0.10 mm).

- Check contact surface of flywheel for slight burns or discoloration. Repair flywheel with emory paper.
- Check flywheel runout.

**Runout (total indicator reading):
Less than 0.0039 in. (0.10 mm)**
