SUBJECT: Air compressor head coolant leakage

Department: Service
 Section: Brakes
 Model(s): ALL
 Model Year(s): 2011, 2012 & 2013
 Effective Date: July 25, 2014
 Form #: TB BR-11
 Rev #: N/A
 Supersedes: N/A

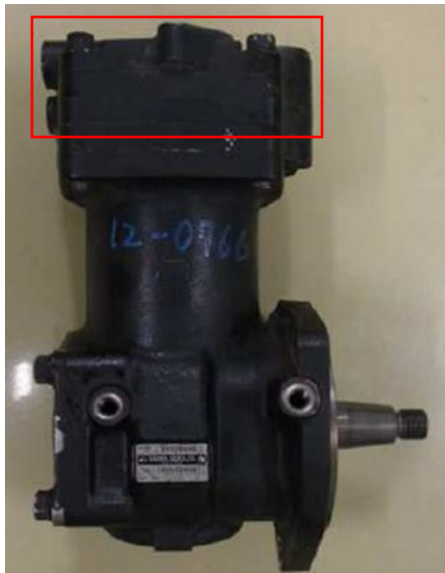
Air compressor head

Coolant leakage occurs in the air compressor head from damaged head gasket and valve seat. The damage is caused by cavitation due to coolant boiling.

Head gasket

Valve seat

Air Compressor Head Repair Kit **P/N-5222356249** is available through normal parts channel. This Kit contains all parts need to replace the head.

Inspect the air tank and air dryer for the presence of coolant. If coolant is found replace the air compressor head.

1. Refer to IMPACT section 561Cylinder Head, Compressor, Replacement for procedures to replace the air compressor head.
2. Check Coolant level and Concentration. Reference SNL-072 for coolant specifications.
3. Flush the air lines and replace the air dryer desiccant.

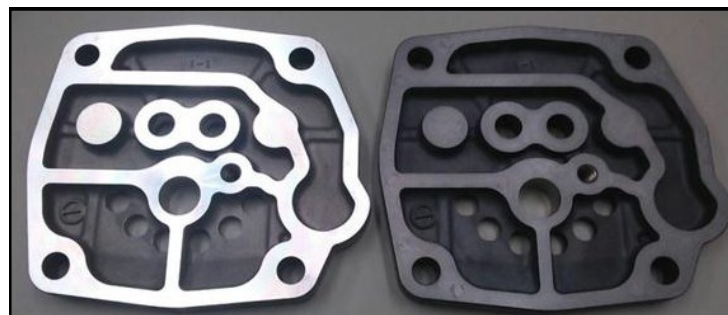
Alunite treatment has been added to the valve seat sealing surface.

w/o Alunite

w/ Alunite
